## PRELIMINARY STRUCTURAL ASSESSMENT REPORT

**PROJECT:** Ronald Reagan Building – 14<sup>th</sup> Street ramps  
Investigation of Ceiling Failure at the 14<sup>th</sup> Street North Vehicle Ramp

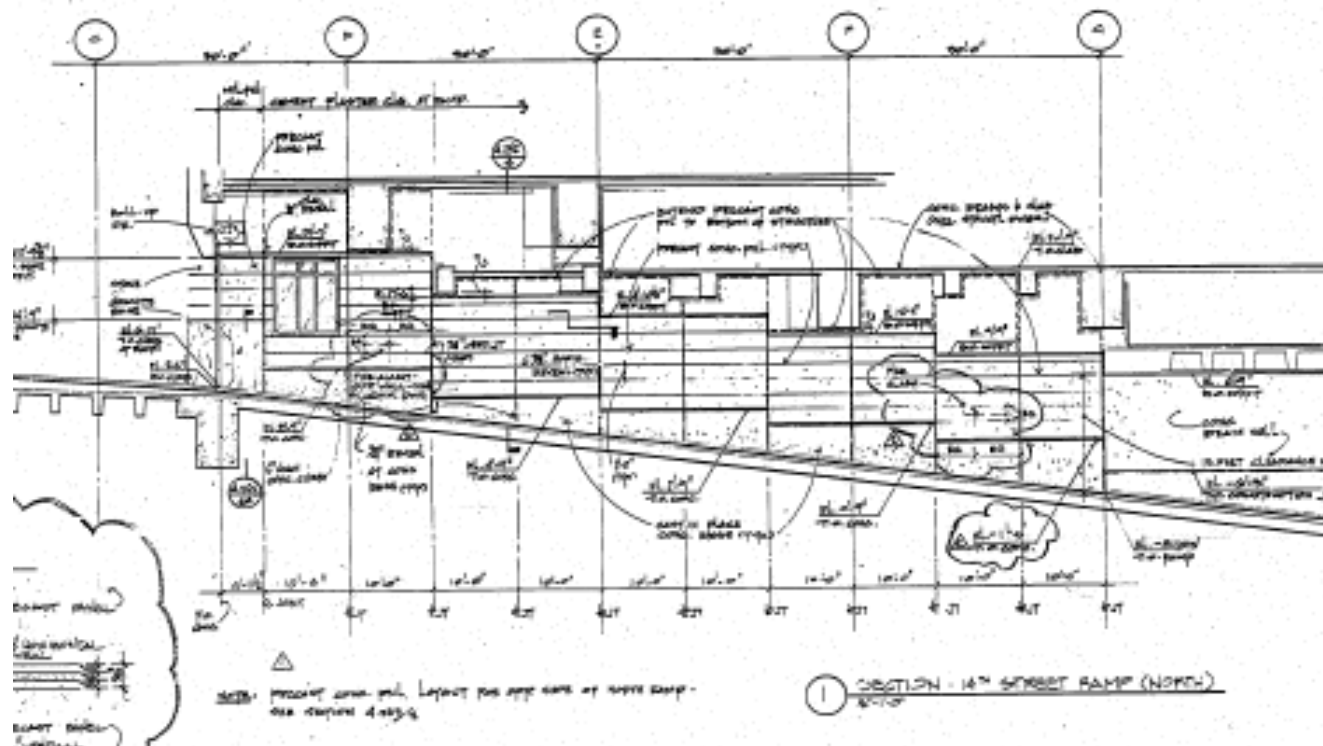
Figure 1: 14<sup>th</sup> Street North Ramp Section

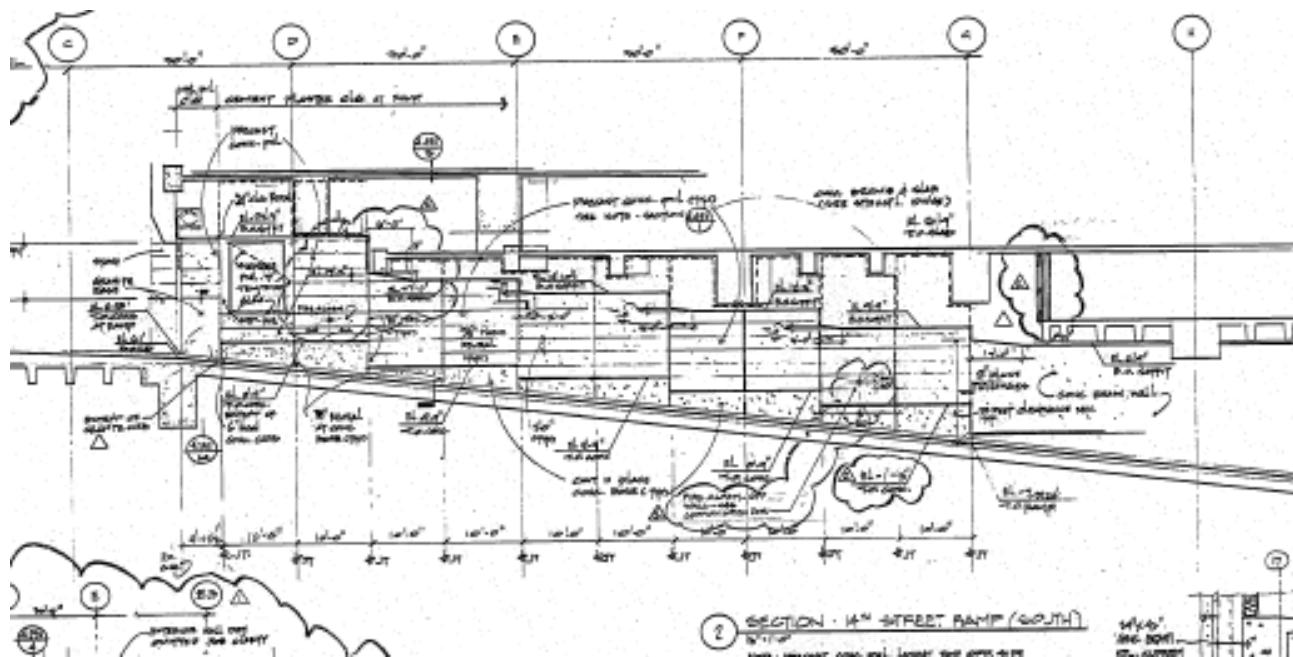
Figure 2: 14<sup>th</sup> Street South Ramp Section

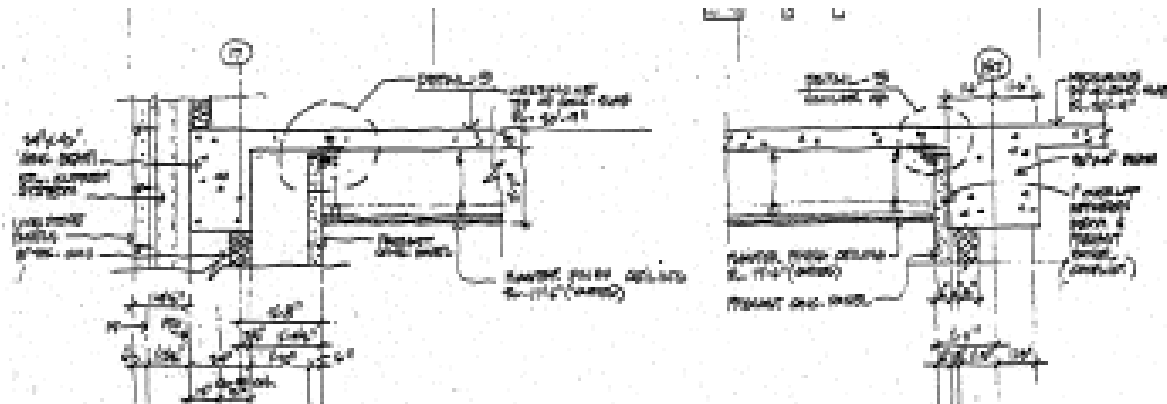
Existing building drawings do not provide ceiling support details even though wire hangers seem to have been drawn in. Specifications for the plaster ceilings were not available at this time. Shop drawings for the plaster ceilings, hangers and framing were not available at this time.

Figure 3: Section showing wire hangers

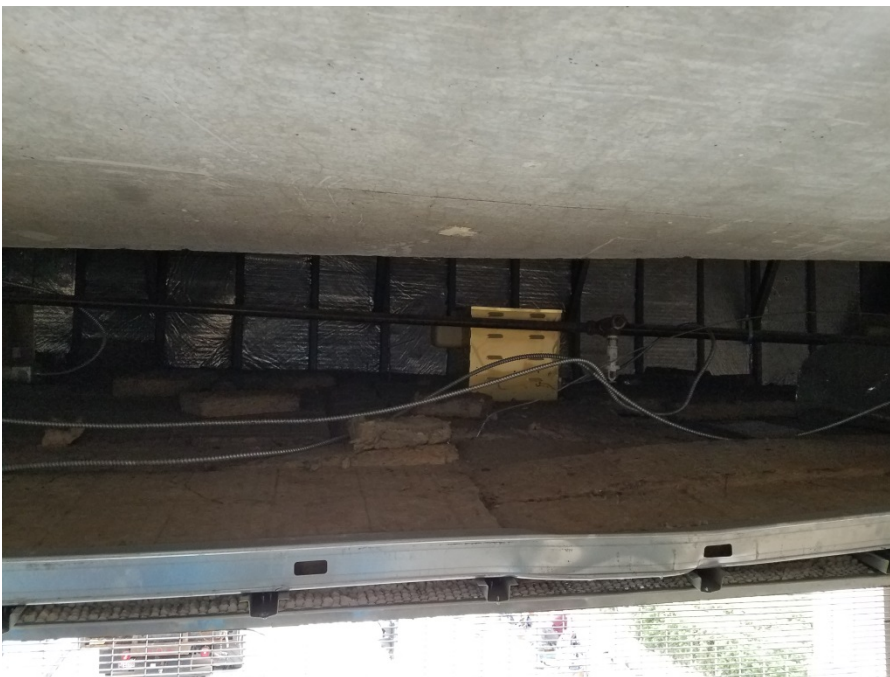
The OPDQ structural engineers observed during the site visit that the ceiling at the 14<sup>th</sup> Street North Vehicle Ramp had collapsed at the second panel location by the entrance and adjacent two panels were sagging. The ceiling consists of approximately ¾” thick plaster ceiling panels approximately 10feet wide with a lath back up (Appears to have been done on site due to different colors of coating) connected to 1 ¼”x2 ½” light gage channels spaced at approximately 12 inches on center. The channels are in turn supported by light gage “C” channels spaced at approximately at the third ceiling panel points. The channels are connected to the concrete ceiling soffit above at approximately 4 feet on centers. “Eye” socket hangers or hammer drilled expansion screws (Approximately ¼” diameter by 1-¼” long) provide the hanging mechanism for the wire hangers. At some locations the ceiling panels appear to be directly hung from wires. Light gage tracks attached to the concrete ceiling by the expansion screws at approximately 12” on center provide support for the vertical light gage studs 3 ¾” deep x 1 ¾” flange that act as the framing for the bulkheads.

Picture 2: Typical existing framing – sagging ceiling at North Ramp

- 1) Keep the 14<sup>th</sup> Street North Ramp closed off and do not have anyone have access to the area.
- 2) Remove sagging and loose ceiling at the north ramp. This was verbally communicated to the Building management and contractors and work is assumed to have begun as of 04/21/2017.

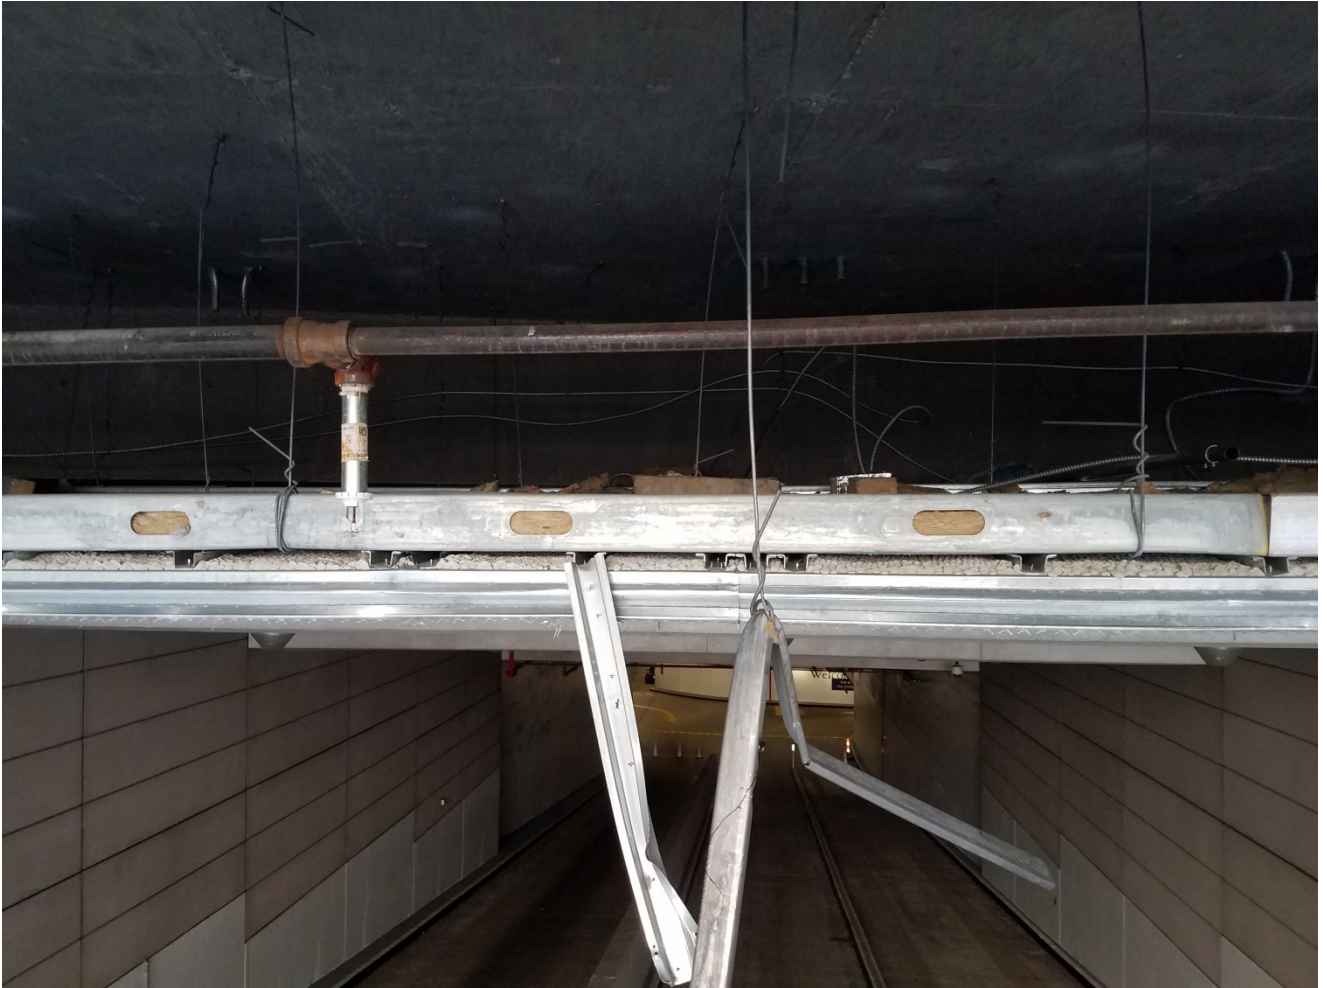
Picture 3: Typical existing framing – sagging ceiling at North Ramp
